# WETLAND IMPACT ASSESSMENT REPORT

**A WETLAND IMPACT ASSESSMENT FOR THE PROPOSED UPGRADE AND  
EXTENSION OF THE LIBANON LANDFILL SITE IN THE RAND WEST CITY  
LOCAL MUNICIPALITY, GAUTENG PROVINCE.**

**REVISED 20 MAY 2026**

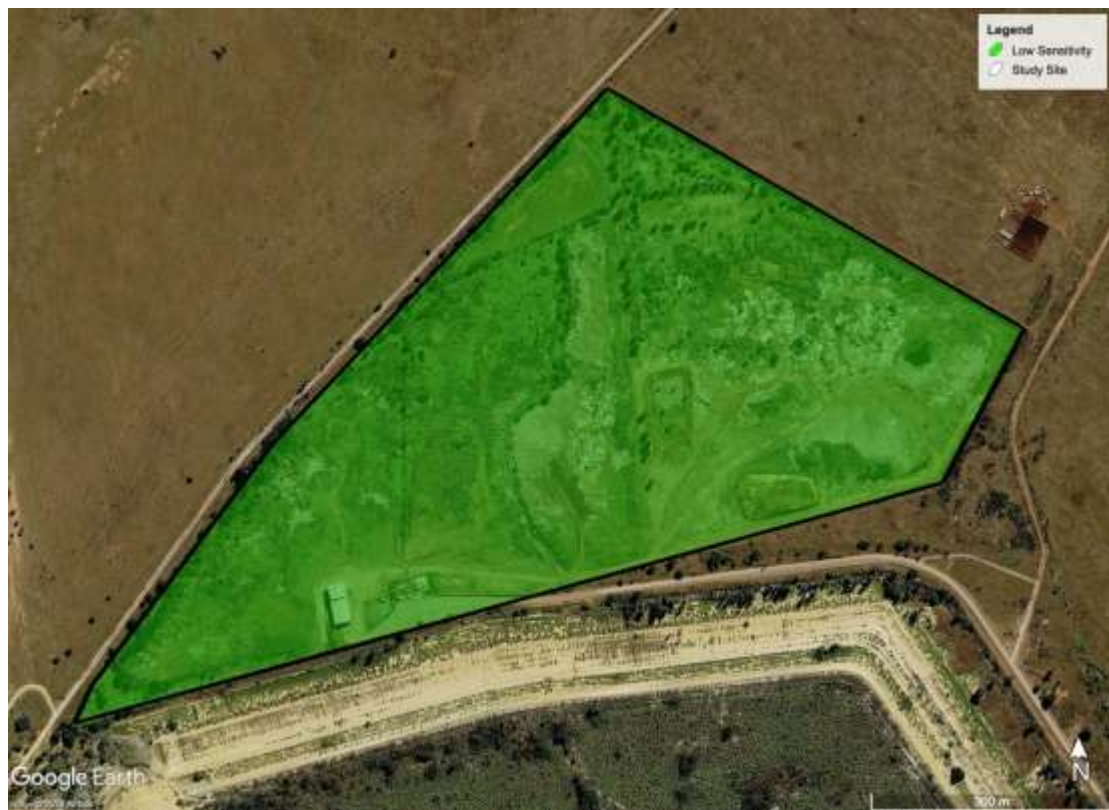
**Sensitivity map of the study area**

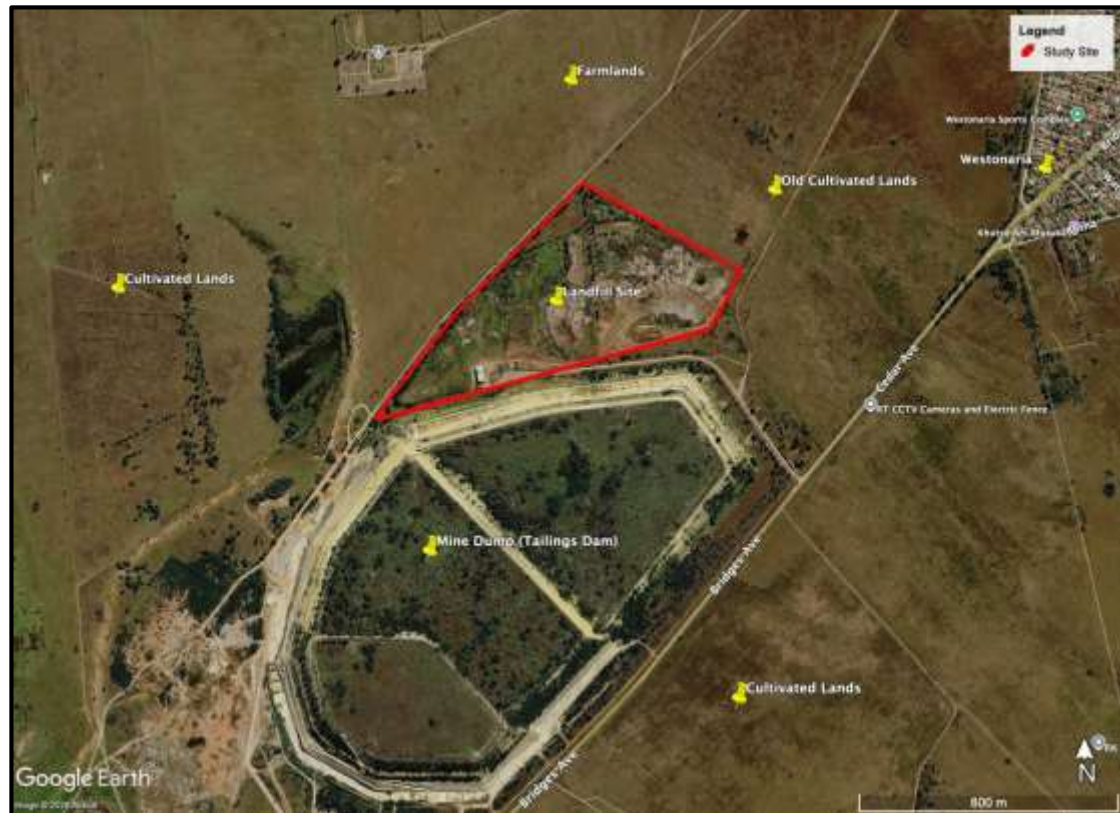
Figure 8: Environmental & Current Landuse Map (2026)

The landuses have not change significantly between 2017 and 2026. A visible contrast is the increase in inactive cultivated land in the vicinity between the Libanon Landfill Site and the urban area of Westonaria. A comparison of the Environmental and Current Landuse Plans of 2017 and 2026 (during the same period of the month of May) are shown below (Figure 8, Figure 9).

The landcover or landuse of the area is predominantly cultivation and farmlands, with the dense, urban areas of Westonaria to the northeast and Libanon to the immediate southwest. Other landuses include mining activities, tailings dam and of course the Libanon Landfill Site. The study area consists of an existing and operational solid waste site (landfill site) and cultivated farmland.

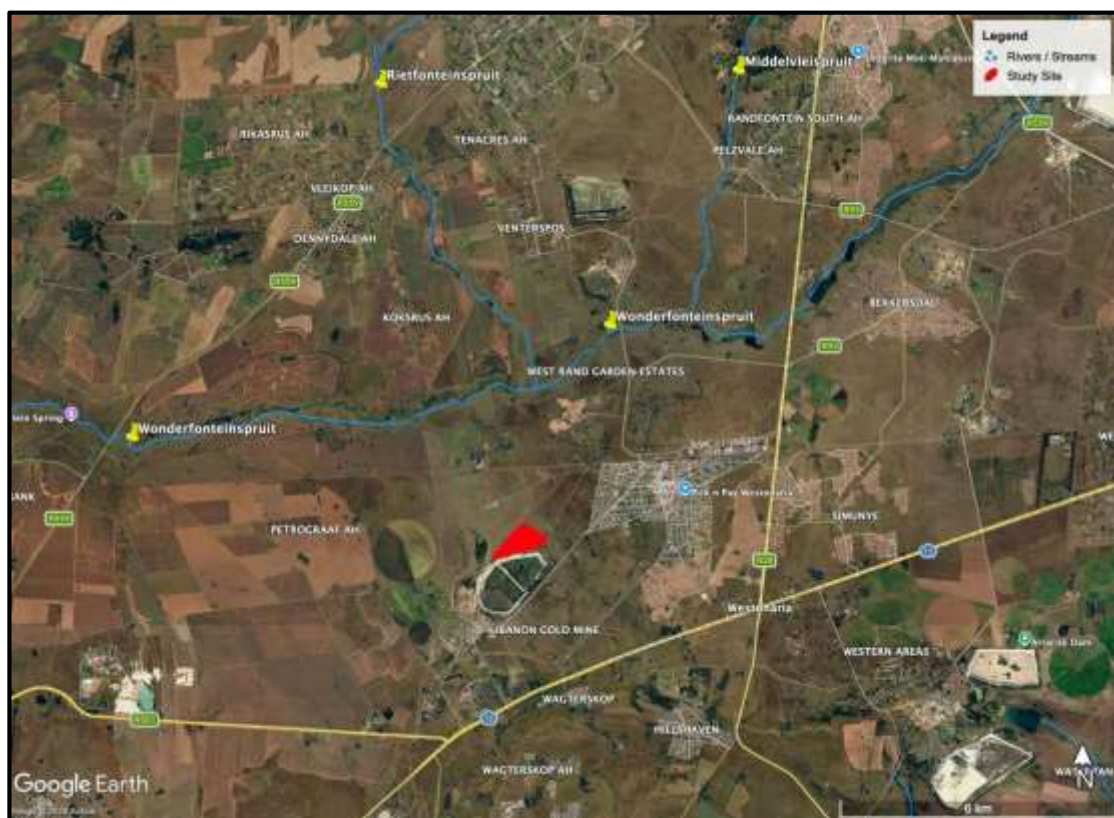
**Figure 13: Wonderfonteinspruit**

The closest river / stream to the Site is the Wonderfonteinspruit (See Figure 13, below), which is a major perennial river, and is approximately 3 km to the north of the site. The Wonderfonteinspruit flows in an east to west direction on the northern side of the site.

This piece of river is unique in that it is piped (transported) in a steel pipe, 1 m in diameter, for approximately 25 km from the Donaldson Dam (attenuation dams) in the north-east, to the town of Carletonville in the west, where the water is released back into the river.

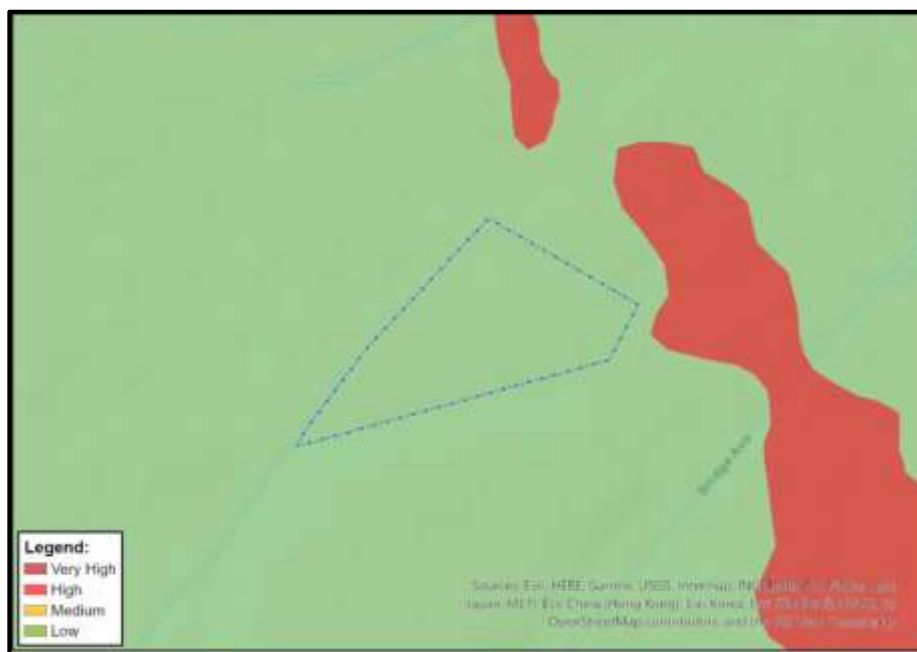
**Figure 21: Screening tool assessment sensitivity map for the aquatic biodiversity theme**

The National Screening Tool ([www.screening.environment.gov.za](http://www.screening.environment.gov.za)) is a desktop assessment and guideline. The assessment of the aquatic biodiversity theme sensitivity for the study site 'Low' (Figure 21).

During site investigations the screening tool assessments were assessed and ground truthed and the aquatic biodiversity theme sensitivity was found to be 'low'. That is, confirming the screening tool assessment for the study site. There are no watercourses on the study site.

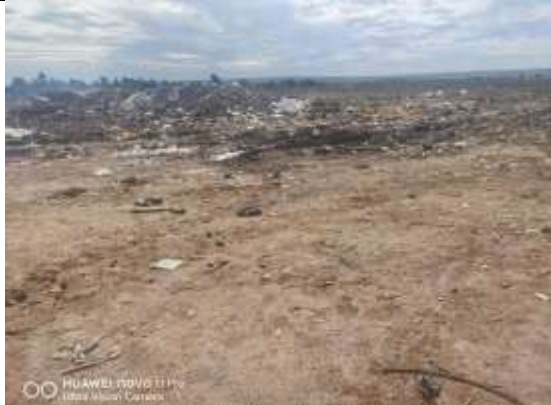
| General view of the existing landfill site | Accumulation (ponding) of surface stormwater run-off on the landfill site |

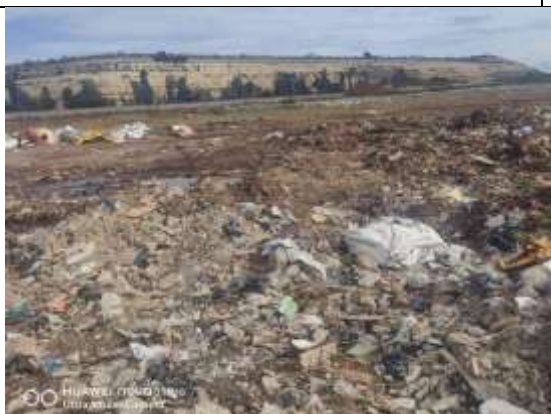
| Dump site with large mine dump (tailings dam) in the background | General view of the study area and landfill site |

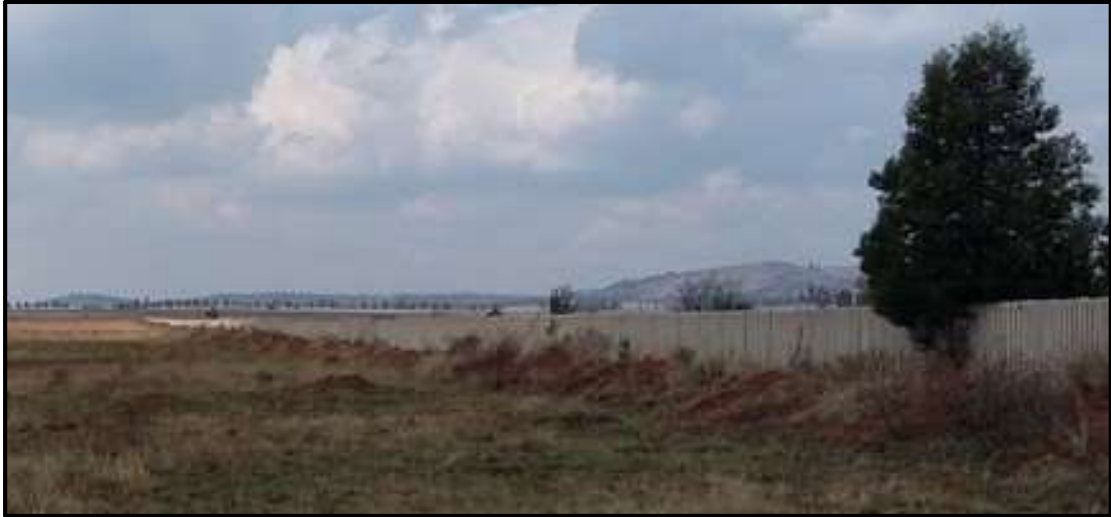
**Photo 1: Palisade Fence on the Perimeter of the existing Libanon Landfill Site (2017)**

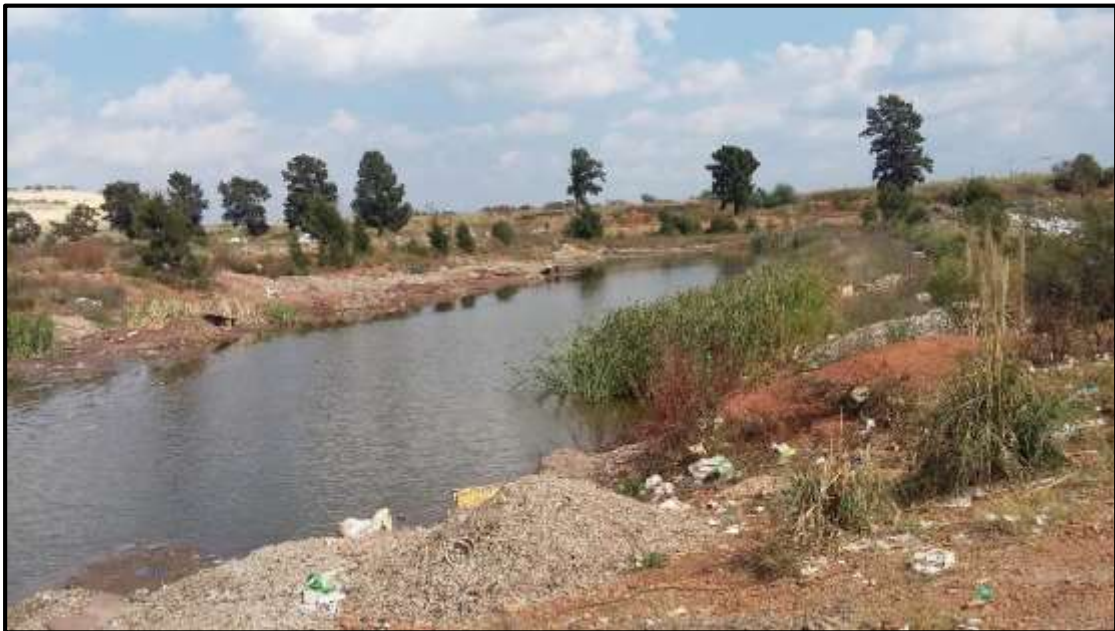
**Photo 2: Stormwater run-off into excavated holes on the Libanon Landfill Site (2017)**

- People are living on the site this must be discouraged;
- Illegal mining activities are occurring on the site and this must be discouraged;
- Stormwater management plan including stormwater systems, such as pollution control dams must be properly constructed including and prevention of unnecessary pond or damming of water as is currently occurring on the site;

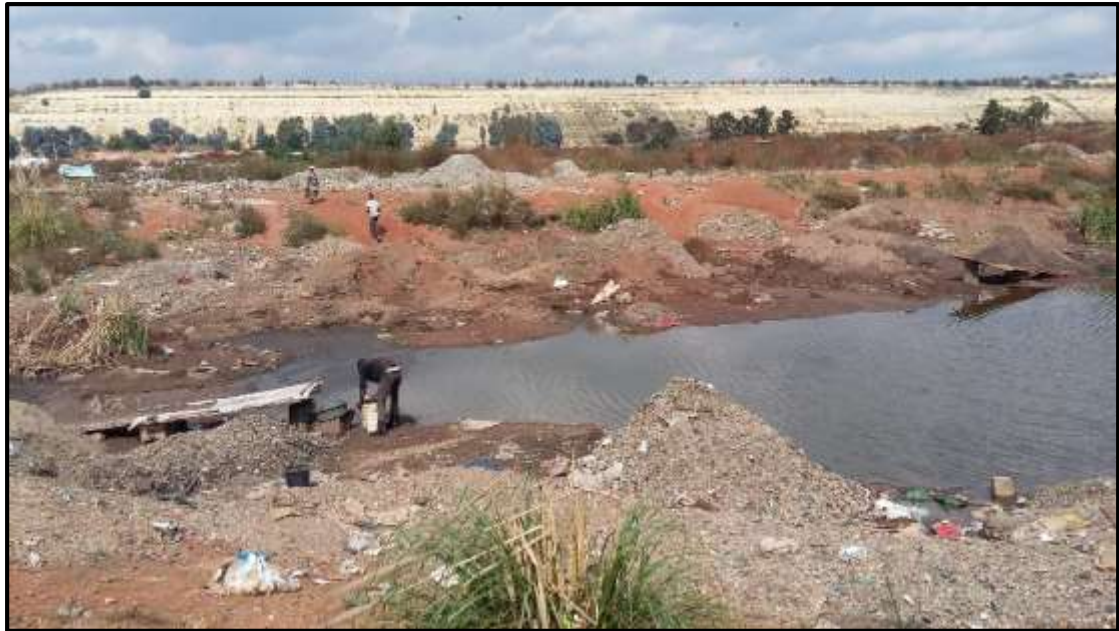
**Photo 3: Illegal mining activities on the study site at the present Libanon Landfill Site (2017)**

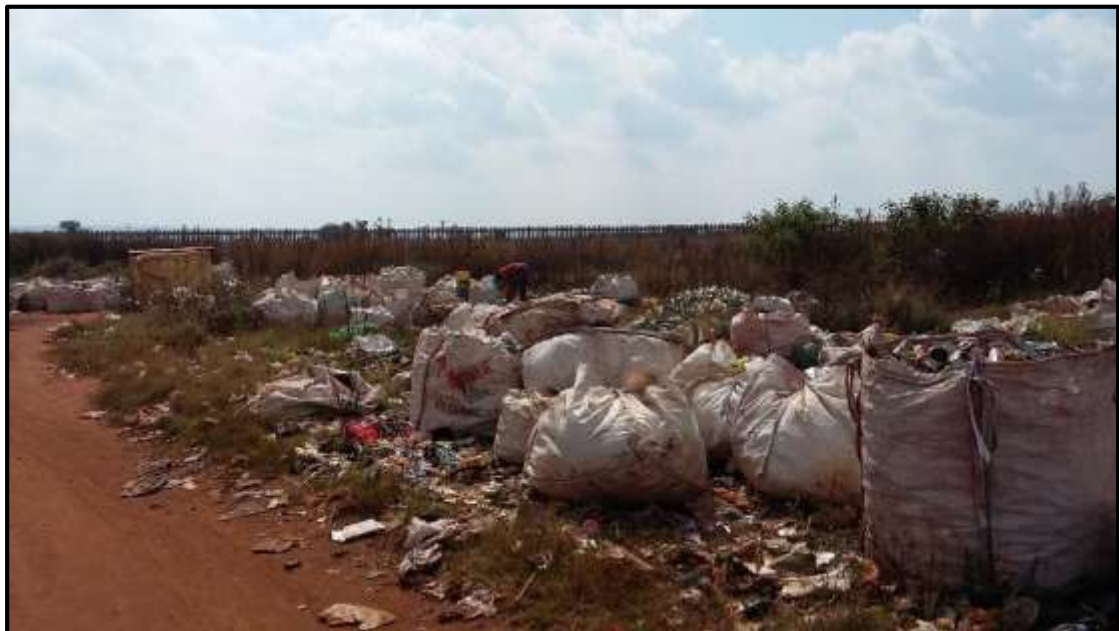
**Photo 4: Recycling of waste at the study site by private individuals (2017)**
